**Study of Warm, Pre-Wetted Sanding Method at Airports in  
Norway**

*Prepared for  
Transportation Development Centre  
of  
Transport Canada*

Norwegian University of Science and Technology  
and  
National Research Council Canada

March 2007

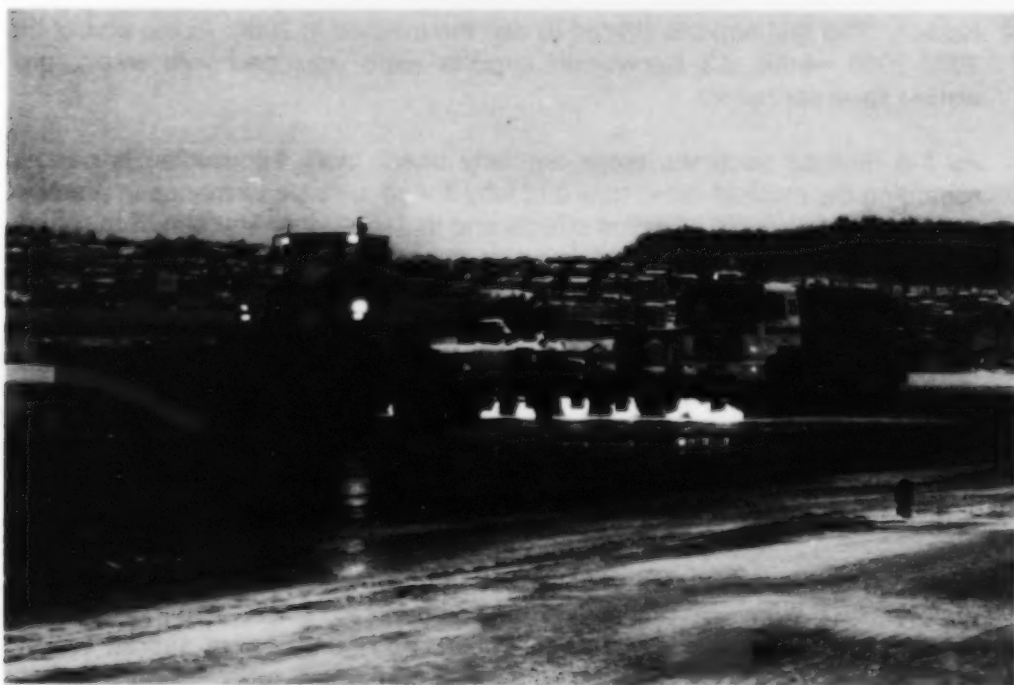
Figure 1. Traditional method of freeze bonding sand to pavement, practised at Norwegian airports. The iced pavement is heated by open flame burners prior to sanding.

It has been recognized for a long time that both effectiveness and durability of sanding operations can be improved by adhering the sand particles to the snow or ice contaminated pavement. Different adhering techniques have been tested and practised, such as using warm sand and heating the contaminated pavement prior to the application of sand. The latter method is still practiced at some Norwegian Airports, as illustrated in Figure 1. Heating the iced pavement partly melts the ice. When the thin water layer refreezes, the sand becomes bonded to the pavement. The method can give good results, but is very time consuming and not energy efficient. It can take several hours to treat a whole runway surface.

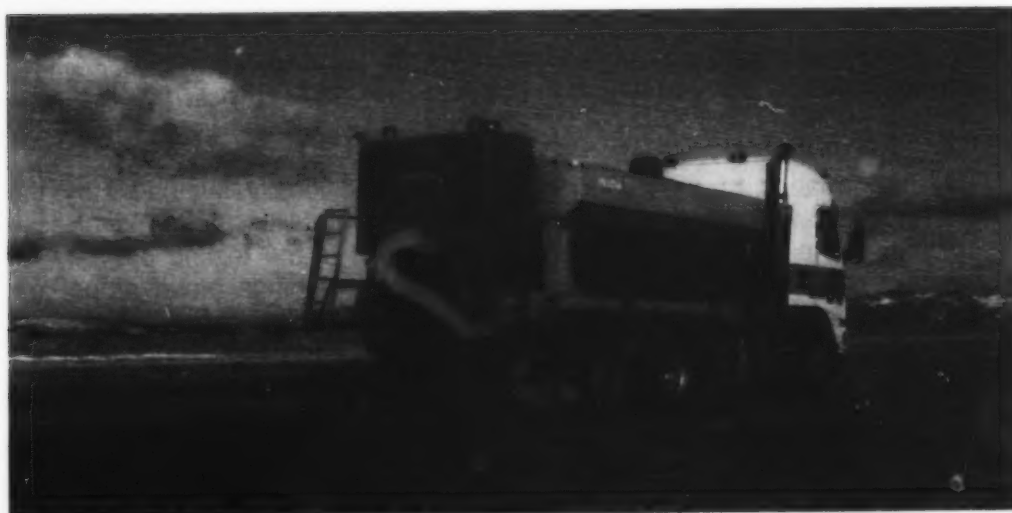
**Figure 2. Sand spreader with warm, pre-wetting functionality.**

An example of a sanding truck with warm pre-wetting functionality is shown in Figure 2. The truck carries 9 m<sup>3</sup> sand and 2700 L water. The water in the tanks is pre-heated to 45°C. During application the water is further heated to 95°C and mixed with the sand in the feeding tube of the rotating disk spreader. The water is heated by three fuel driven heaters.

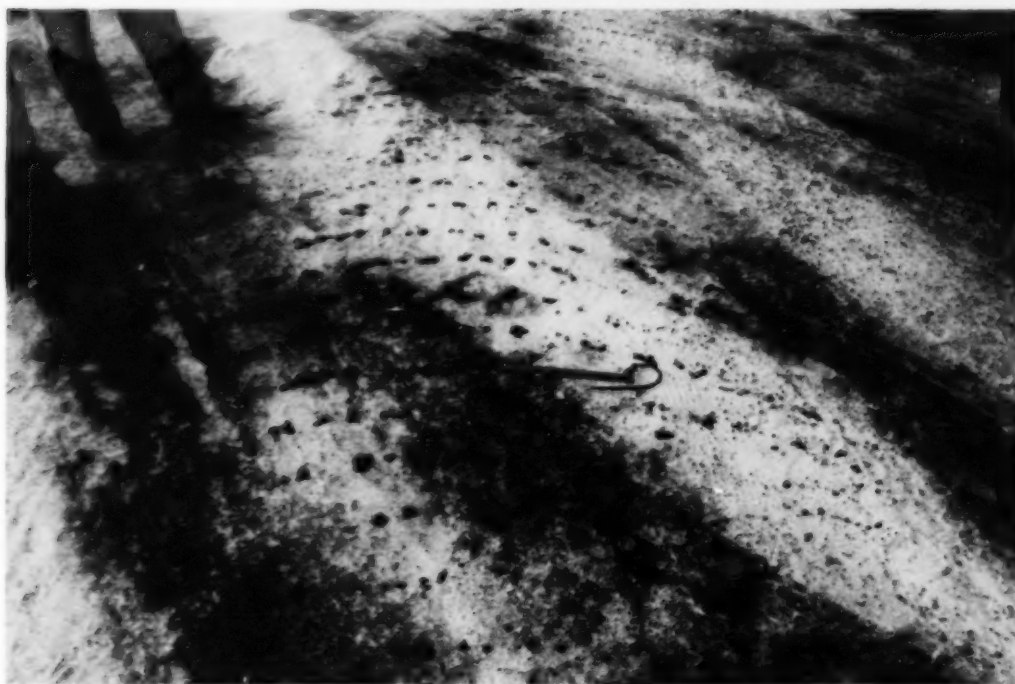
Figure 8. Overview of an area with patches of ice and weakly bonded snow.

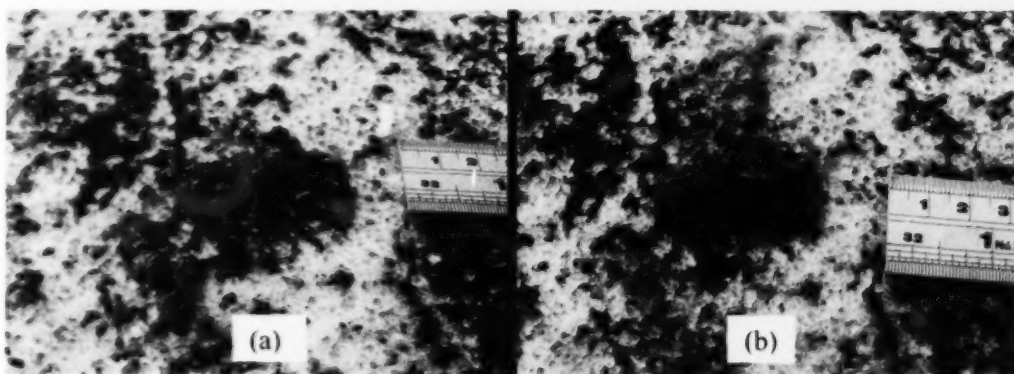
Figure 9. (a) Lump applied on cleaned iced surface. (b) Rubbing the lump causes it to disintegrate into separate particles, leaving brown-looking ice behind.

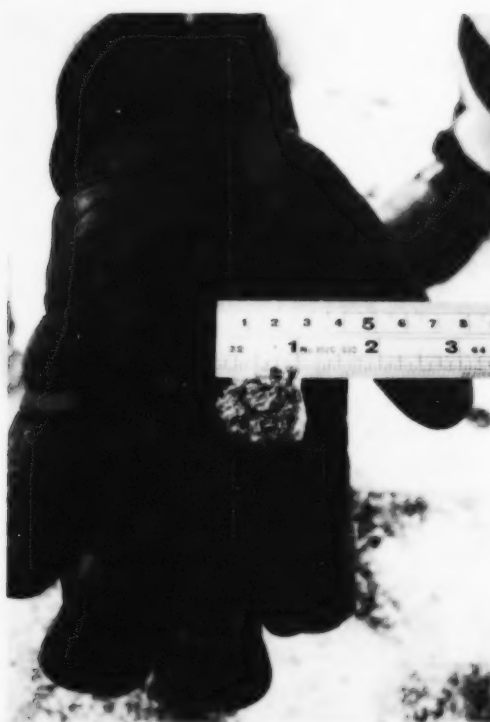
Figure 11. Detail of the lump that broke loose.

lump does not disintegrate in single particles but breaks loose as a single piece (see Figure 10). A detail of the lump is shown in Figure 11 that clearly exceeds the dimensions recommended by the sand guideline.

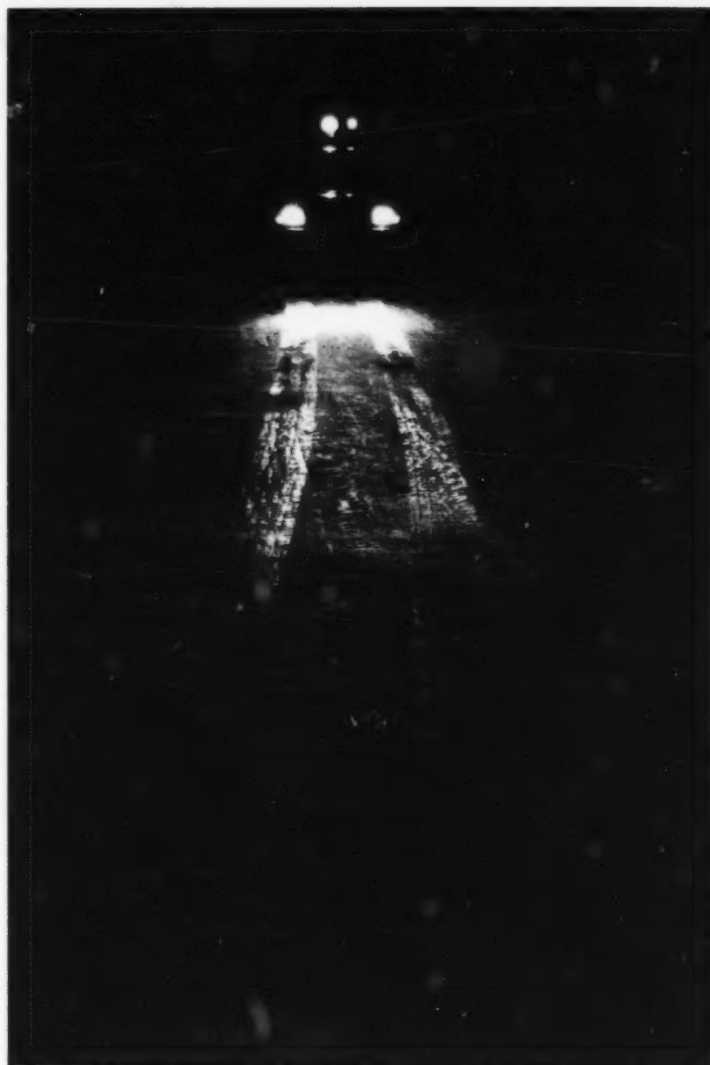
**Figure 21.** Skid marks observed after comment 12. The skid marks are located just before the point where the aircraft made a 180° turn on the runway. A pile-up of snow and sand can be seen at the end of the skid marks.

The skid marks observed after comment 12 are shown in Figure 21.
